## FBCA Board Meeting Minutes

# PRELIMINARY STRUCTURAL ASSESSMENT

Preliminary Structural Assessment  
Fanny Bay Community Hall  
7793 S Island Hwy, Fanny Bay, BC

October 9, 2025

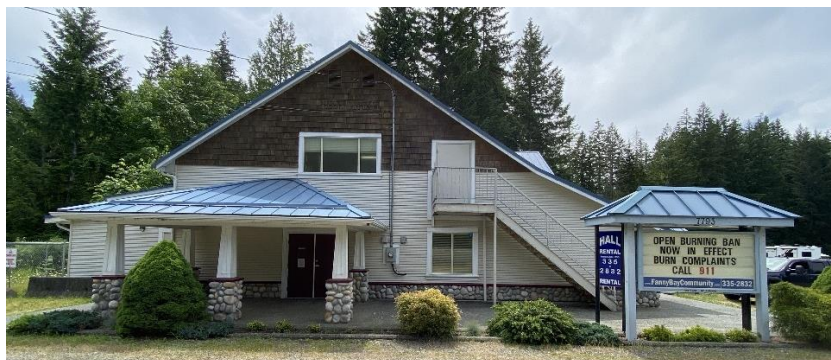
*Figure 1 Northeast Elevation of the Hall*

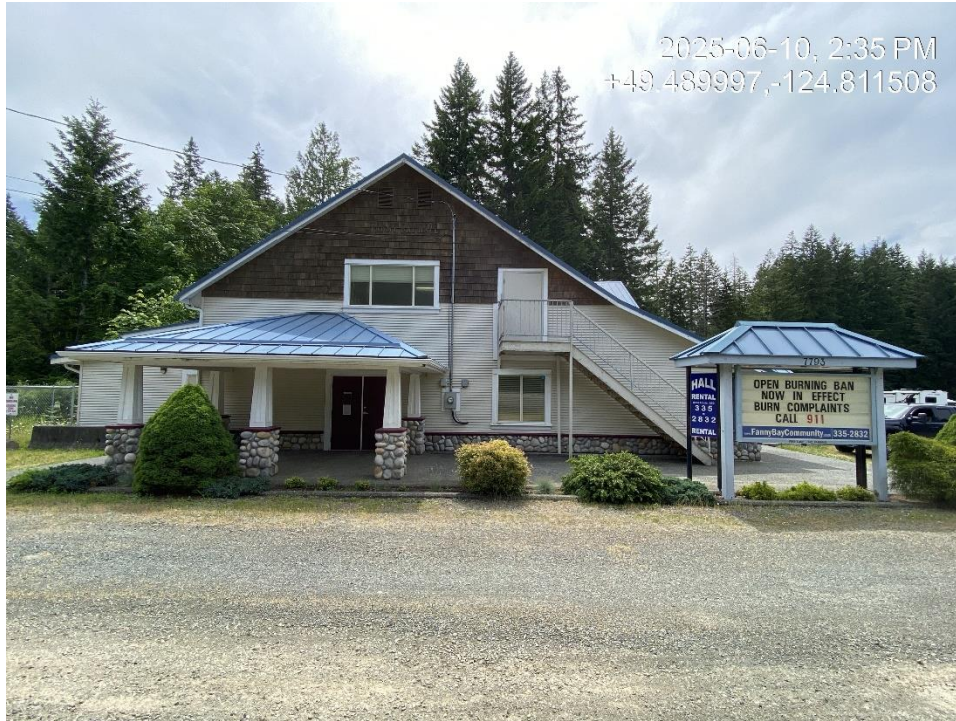
Figure 2 Northeast elevation

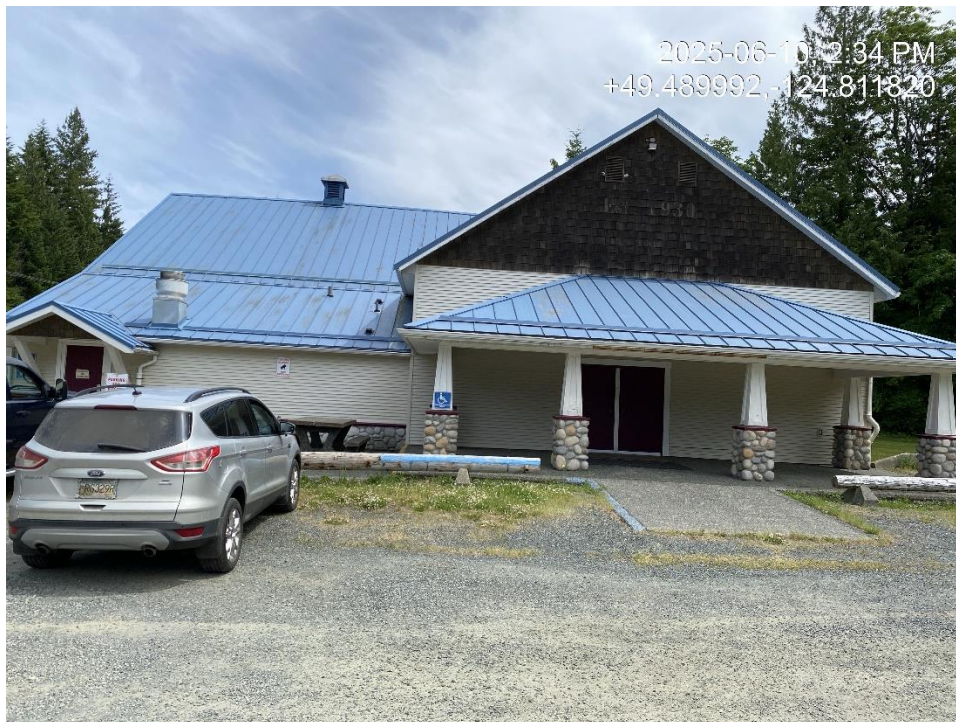
Figure 3 Northwest elevation

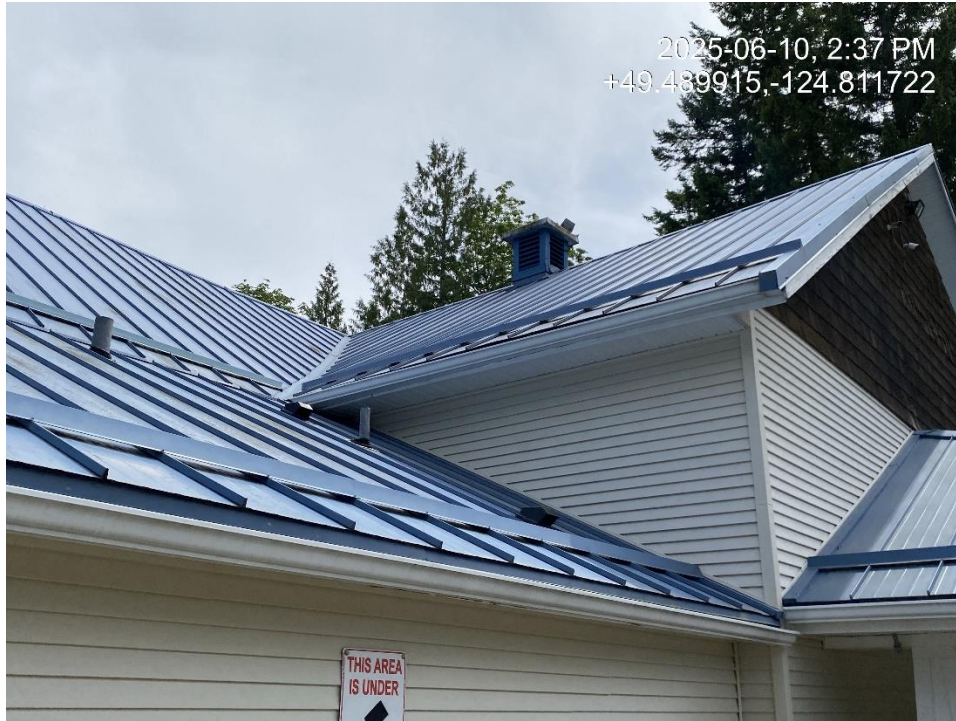
The upper floor studio roof is comprised of 1x6 horizontal strapping on 2x6 rafters spaced at 16" on center supported on 6x6 beams and posts. At the intersection with the main hall roof, valley framing is set on top of the main hall roof rafters. Substantial deflection of the valleys is visible from the exterior.

*Figure 4 Typical deflection at valley framing*

The roof framing is generally overspanned and excessive deflection of individual rafters and beams was observed. Due to the deflection of the main hall roof system and outward thrust on the exterior walls, it is recommended that structural design for repairs should be completed. Repairs are expected to consist of a combination of roof framing repairs and new tension ties installed at the top plate level.

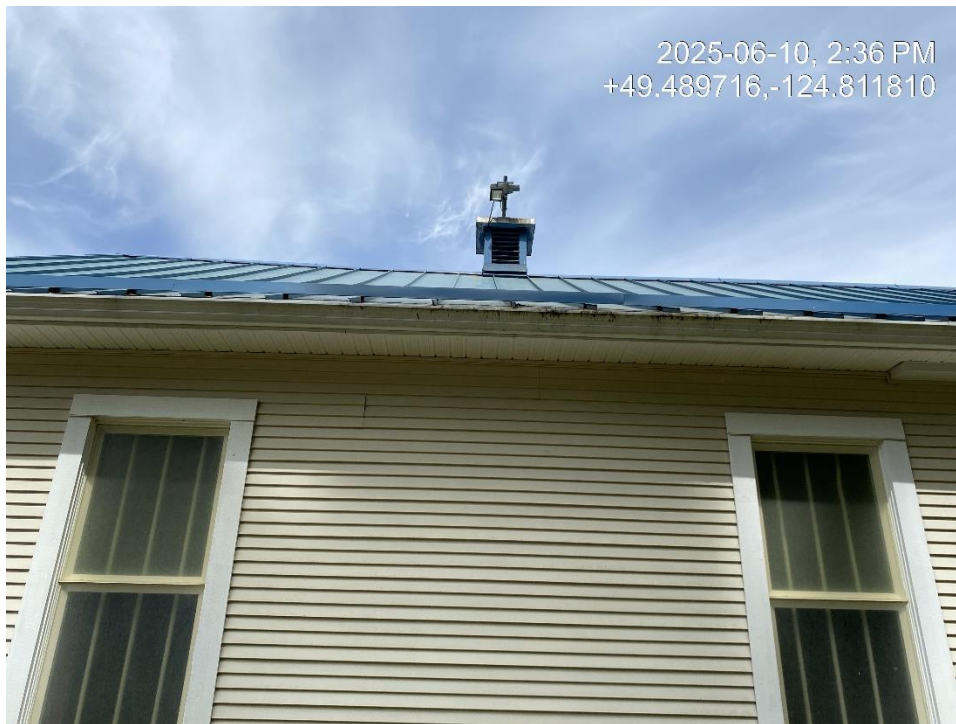
The main hall roof consists of 1x6 horizontal strapping on 2x6 rafters spaced at 16" on centre with raised ceiling ties spanning approximately 36'. Substantial deflection of the roof rafters is visible from the exterior, likely due to the rafter to ceiling tie connection not being designed to adequately resist the outward thrust of the roof rafters.

*Figure 5 Roof framing deflection over the main hall*

Until repairs are completed, it is recommended that the roof snow stops be removed and that occupancy of the hall be avoided during high snow load events. Annual structural reviews of the building are recommended until repairs have been completed.

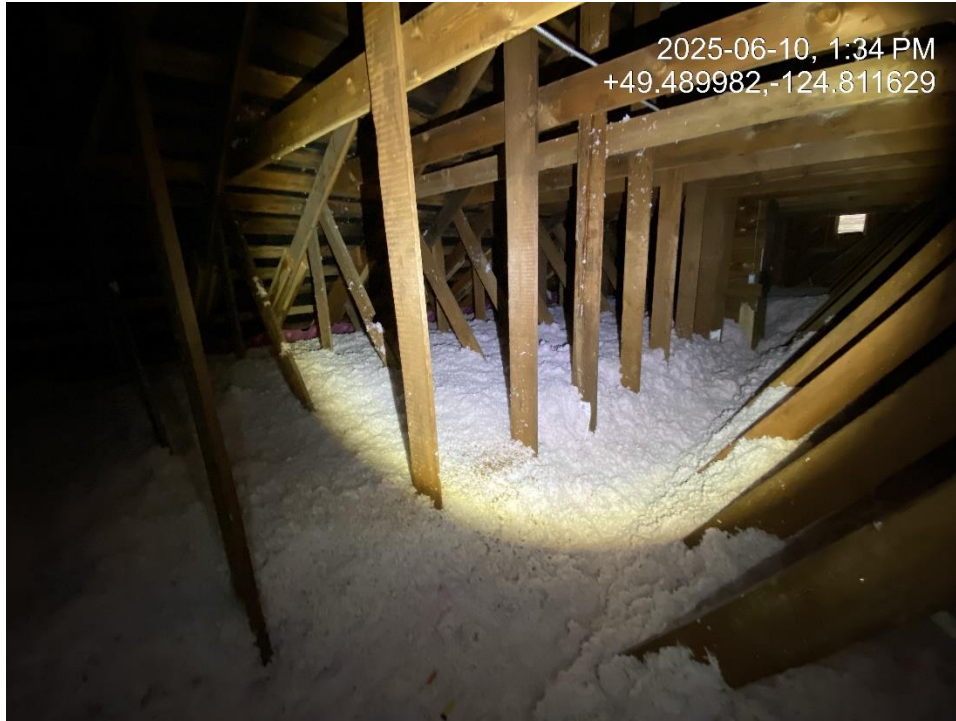
*Figure 6 Roof framing over the main hall*

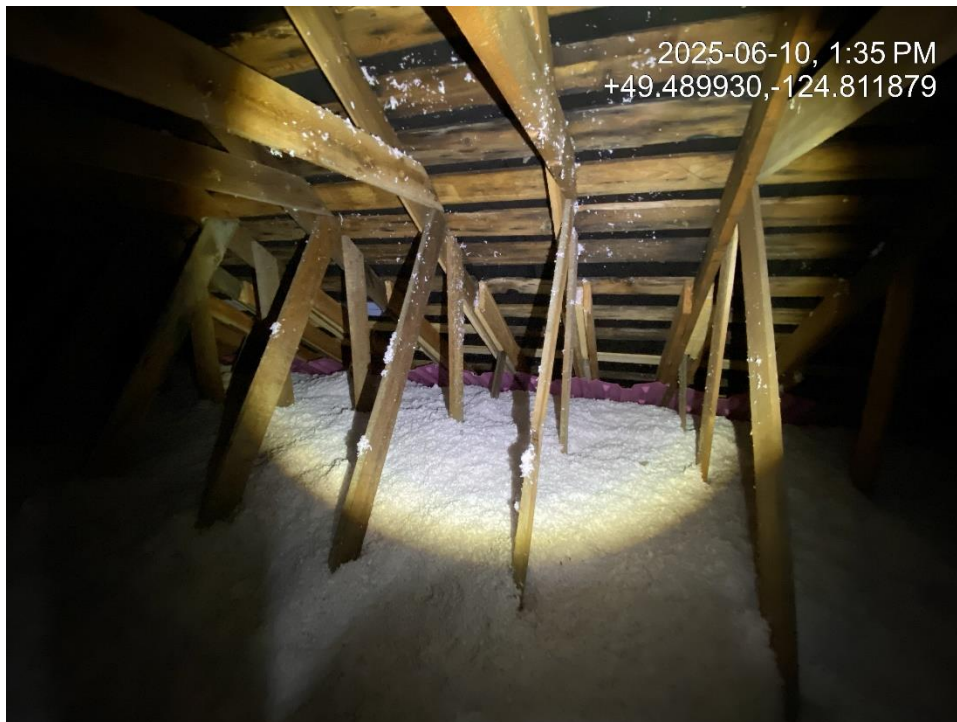
Many rafters have been sistered with additional 2x6 members and steel cable tension ties have been installed at the top plate height. It was noted that the Crosby clips on the steel cable tension ties appear to have been improperly installed and have slipped. No engineering record for the roof framing or steel cable tension ties was located.

*Figure 7 Roof framing over the main hall with sistered rafters along lower eaves*

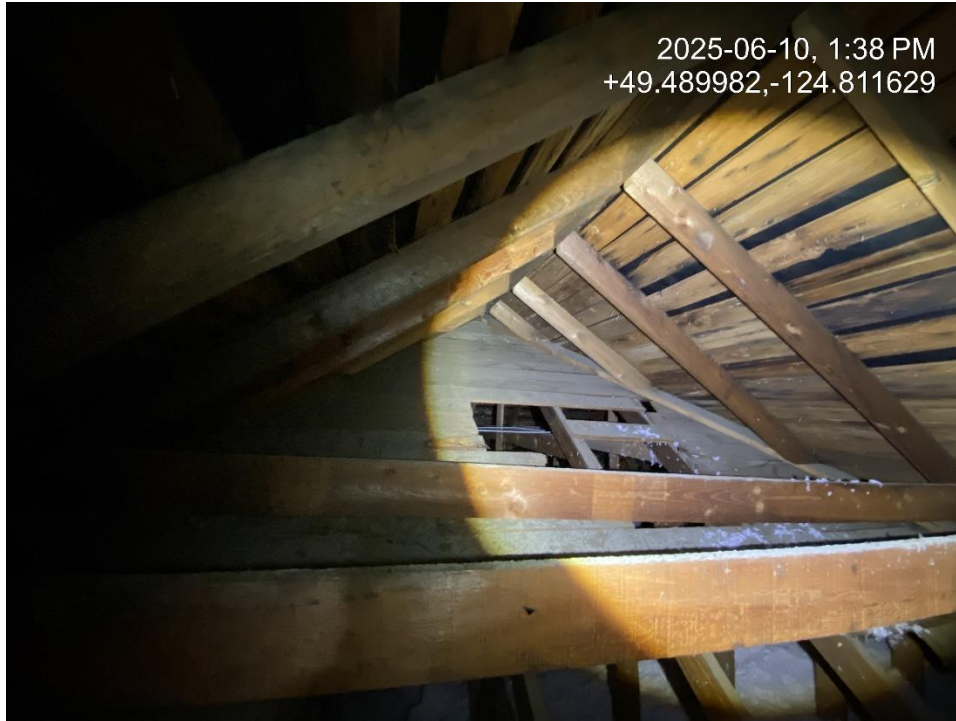
*Figure 8 Intersecting roof framed on top of main hall roof framing*

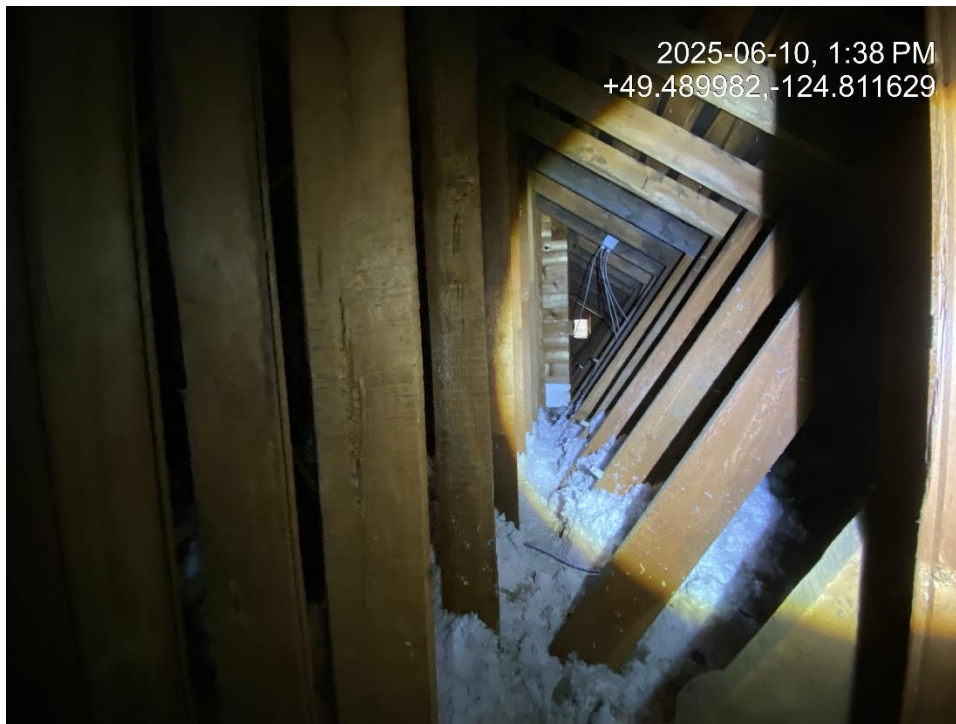
*Figure 9 Studio roof framing*

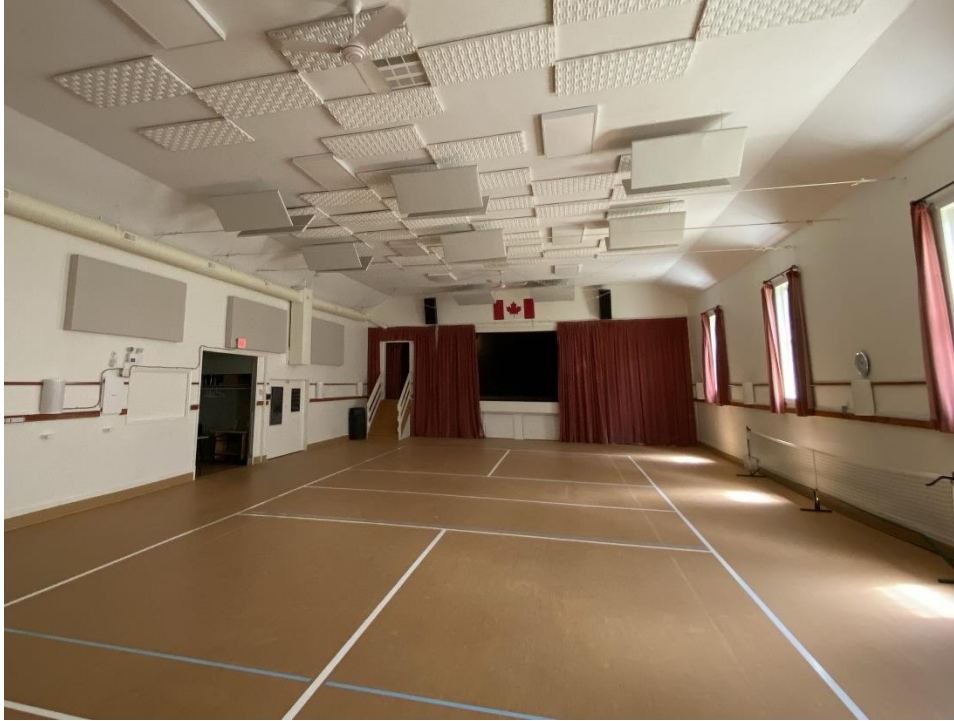
Figure 10 Main hall with steel cable tension ties

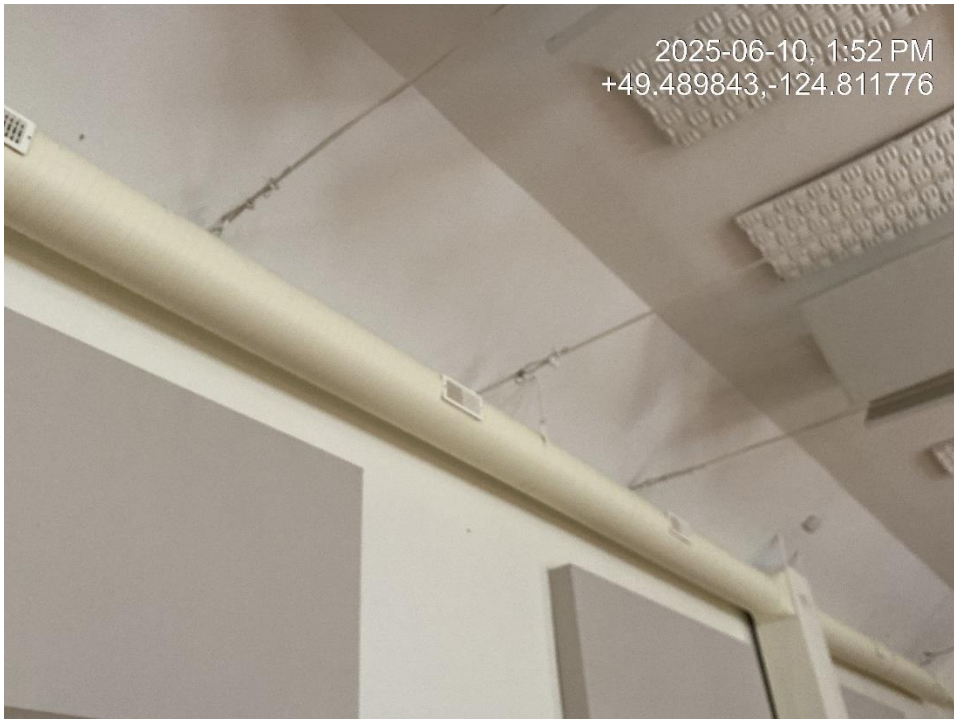
Figure 11 Tension ties

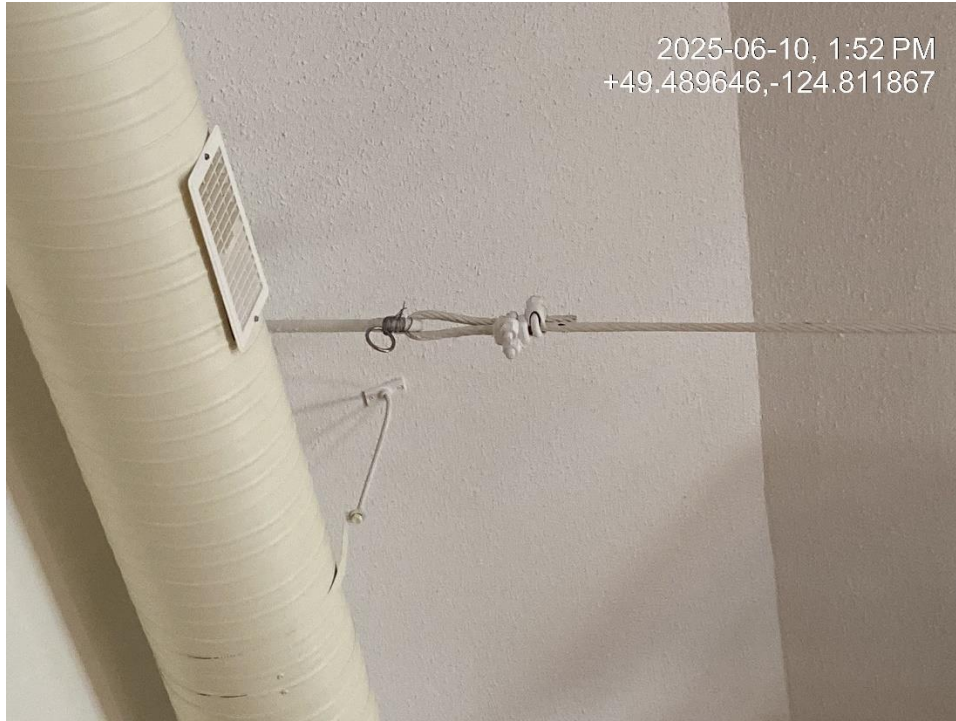
*Figure 12 Tension tie to eye-bolt connection*

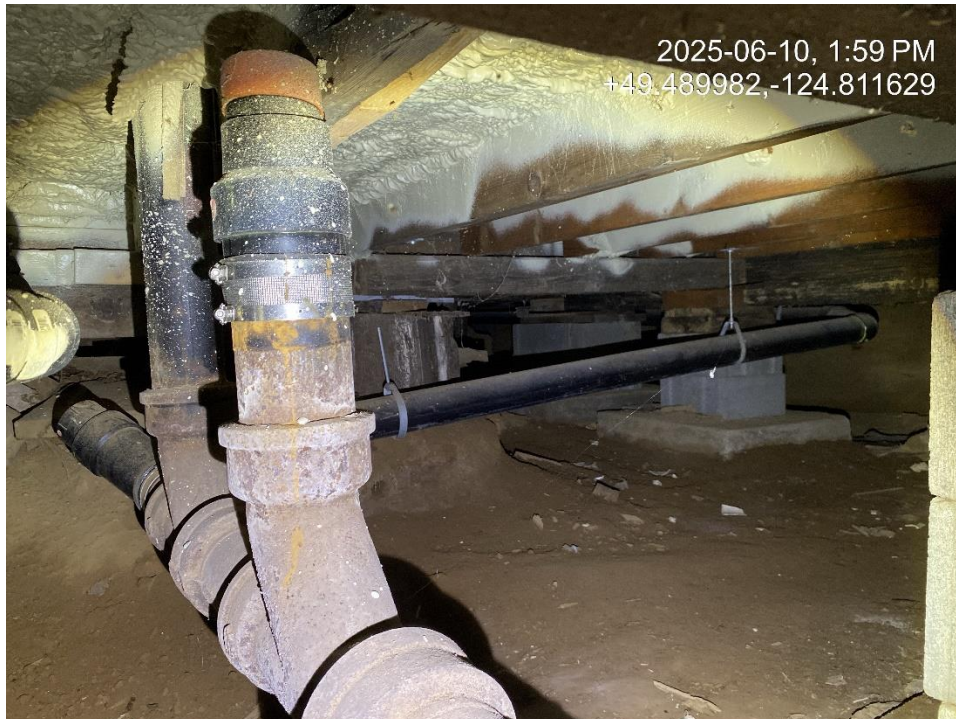
The foundations of the original building consist of timber floor beams supported on a combination of dry stack CMU piers supported on cast in place concrete pad footings, as well as wood rounds directly in contact with the ground. Anchorage of the building frame to the foundations was not observed.

*Figure 13 Wood and masonry supports*

The building is not provided with suitable foundation systems to support imposed gravity or lateral loads. New perimeter and interior cast in place foundations should be provided to support the building and provide resistance to sliding and overturning from seismic loads. Consideration should be given to allow phasing of the new foundations to proceed in conjunction with other projects.

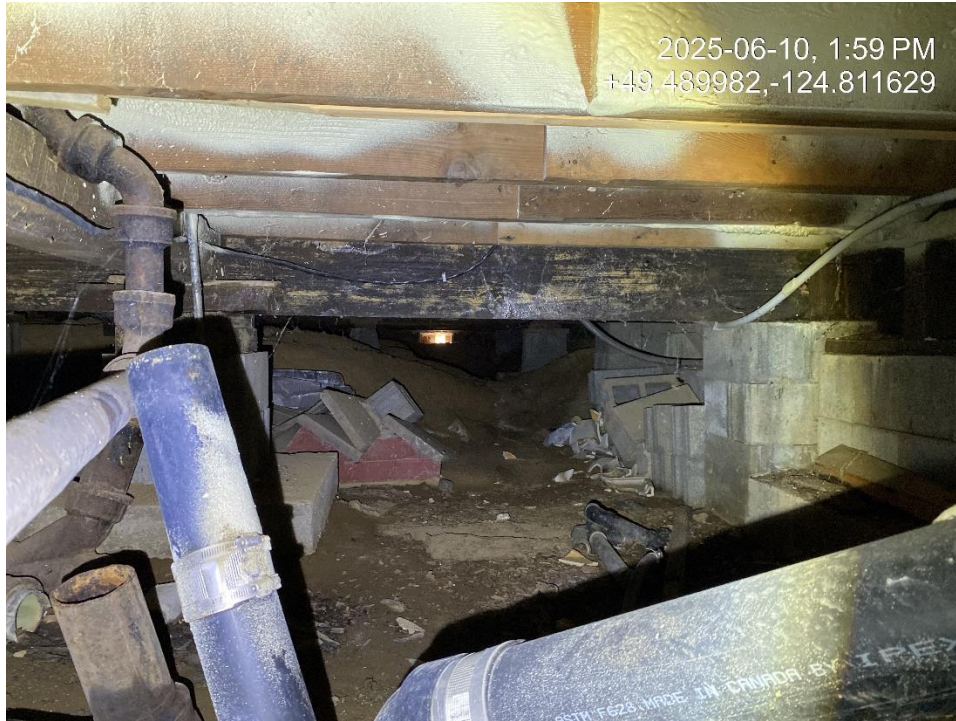
Figure 14 Floor beam and masonry supports

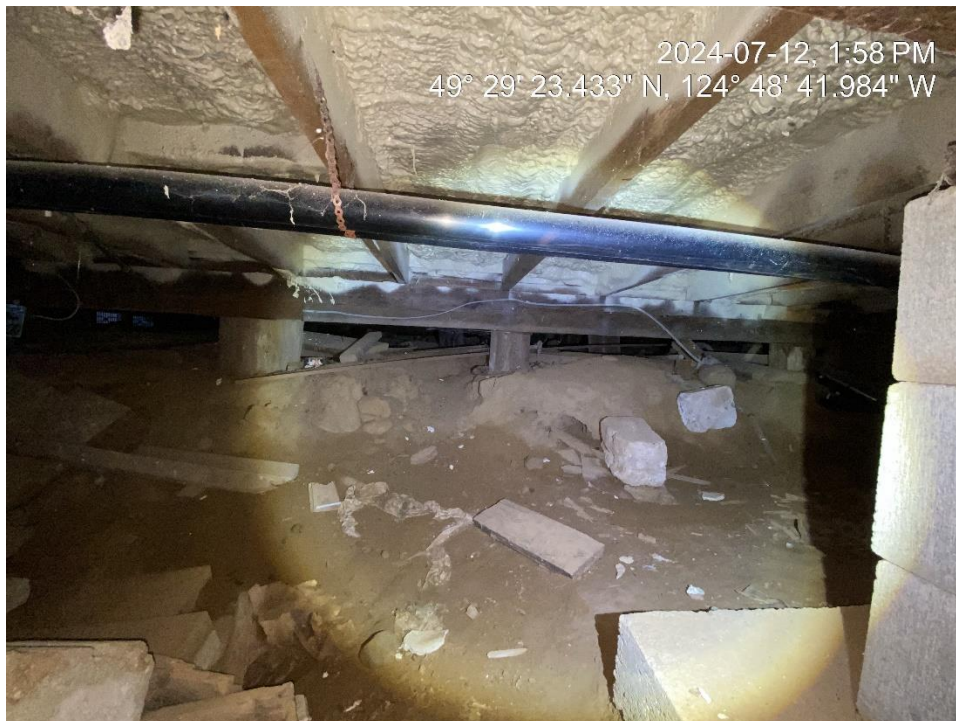
Figure 15 Wood rounds supporting floor beams set directly on the ground

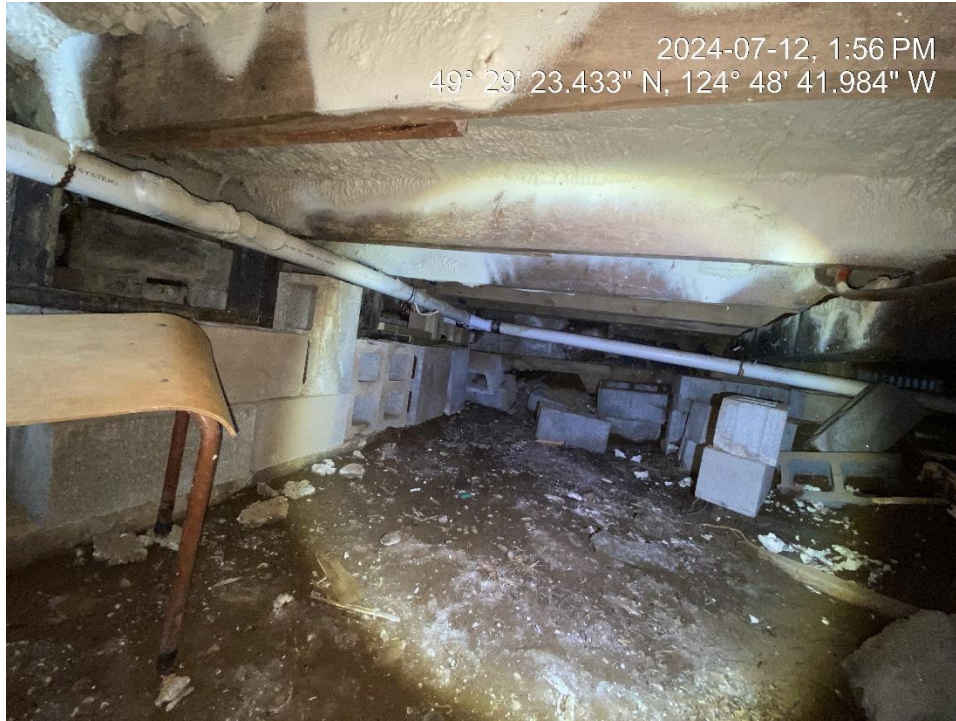
*Figure 16 Masonry rubble wall below the kitchen*

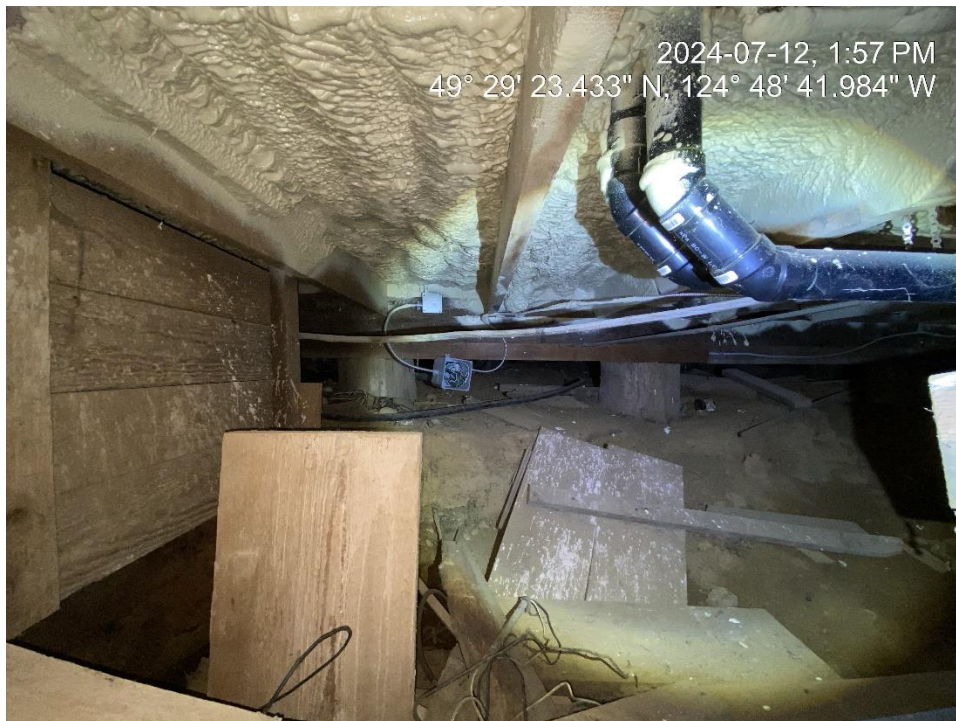
*Figure 17 Wood rounds supporting floor beams set directly on the ground*
