## FBCA Board Meeting Minutes

# PRELIMINARY STRUCTURAL ASSESSMENT

Preliminary Structural Assessment  
Fanny Bay Community Hall  
7793 S Island Hwy, Fanny Bay, BC

October 9, 2025

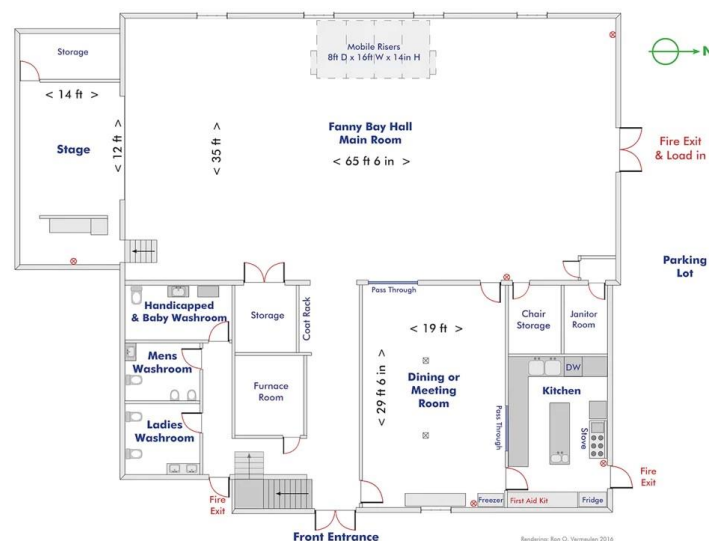
The hall is a 2 storey wood frame building approximately 8.1 m in height and 450 sq.m. in building area constructed in 1931. Building permit records indicate that the front entry and main hall canopies were added in 2009 and a 33 sq.m. bathroom addition was constructed in 2013. The date of the kitchen and stage additions is unknown.

The main floor of the building contains the entry lobby, main hall, meeting room, commercial kitchen and washrooms. An upper floor studio space of approximately 90 sq.m. is accessed by an internal stair and an exterior fire exit stair.
